UNITED STATES ENVIRONMENTAL PROTECTION AGENCY

MEMORANDUM

SUBJECT: ACTION MEMORANDUM - Request for Approval and Funding for a Time-Critical Removal Action at the Harris-Thomas Industries Site, Dayton, Montgomery County, Ohio (Site ID # C5D3)

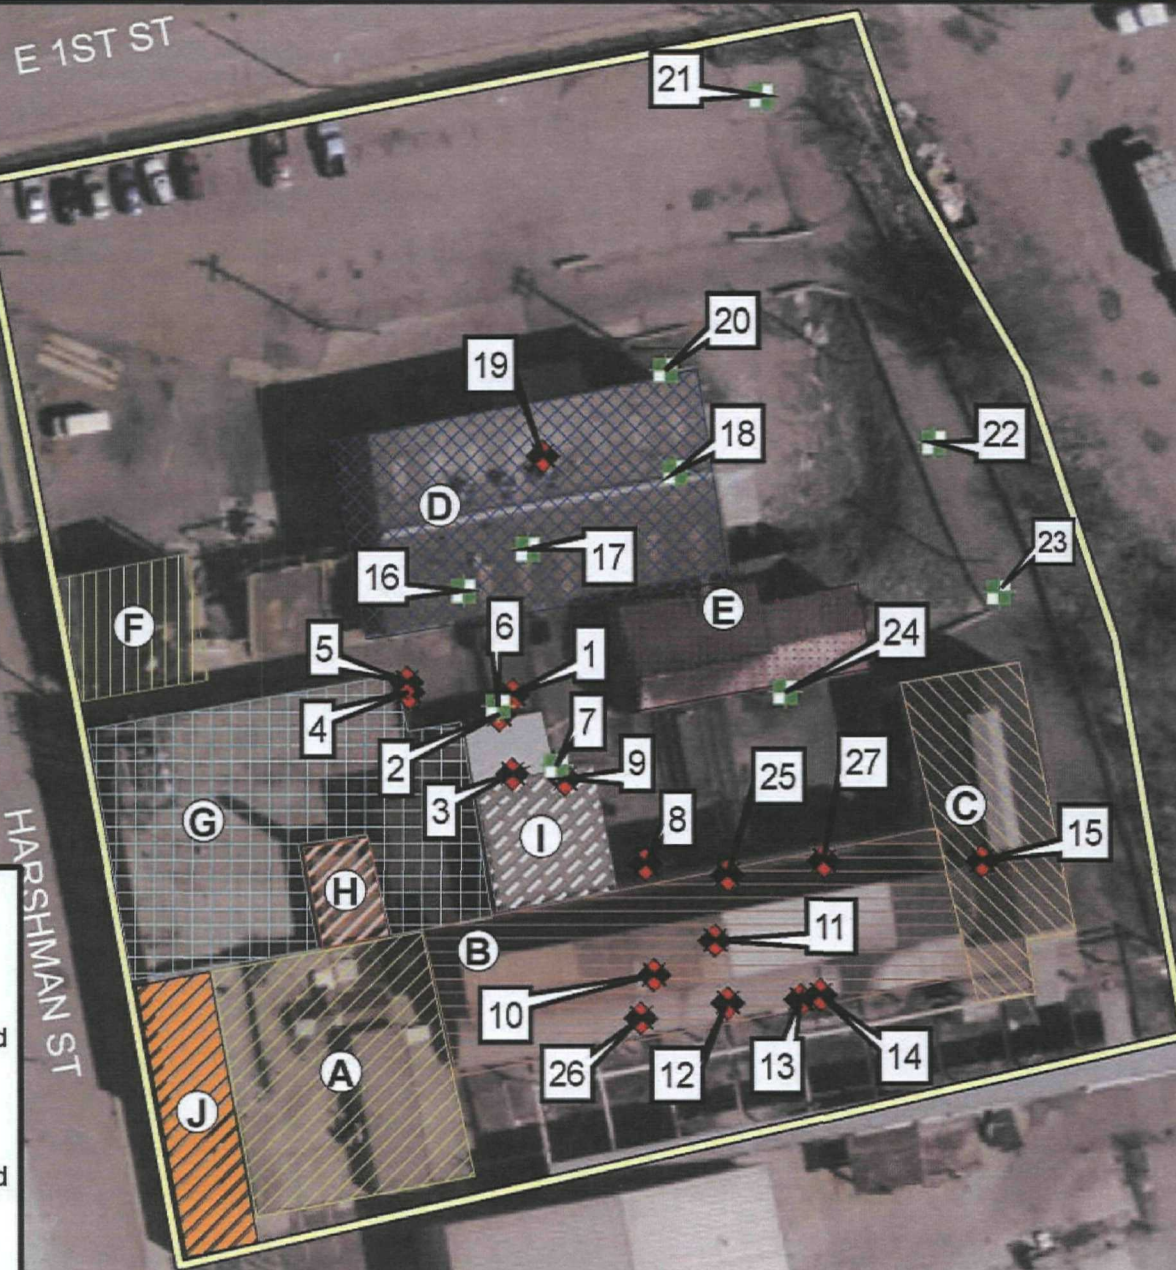
XRF Sampling Location Map
Harris-Thomas Industries Site
Dayton, Montgomery County, Ohio

A total of 34 XRF samples were collected and analyzed with the XRF unit throughout the property. The total lead results from the outside soil, floor sweepings and wall solids were compared to U.S. EPA's Regional Screening Levels (RSL) for the protection of groundwater. The U.S. EPA Superfund Program developed the RSLs as risk-based soil screening levels considered protective of groundwater that may be used to set initial cleanup criteria or help identify areas, contaminants, and conditions that require further federal attention. A total of 24 XRF samples from outside soil, floor sweepings or wall solids showed total lead concentrations ranging from 818 to 57,629 ppm, which exceeds the U.S. EPA lead RSL of 800 ppm (industrial properties). The XRF lead results for the floor sweepings and the wall solids were compared to the RSL due to numerous open bay doors leading to the environment and leaking roofs in each of the buildings. XRF results from waste piles located within 5-feet of a storm-water drain showed total lead concentrations as high as 1,035 ppm. The potential exists for rain to enter the various

Southwestern Ohio receives a substantial amount of precipitation during spring, and winter temperatures are normally below freezing with regular snowfall. Weather conditions will contribute to the further deterioration of the building and waste drums. The building is abandoned and the electricity service has been turned off. There is nothing to prevent freezing and thawing of the contents in the drums and containers. The doorways are open and the building roofs are leaking. U.S. EPA observed unknown solids with total chromium concentrations as high as 7,085 ppm and total lead concentrations as high as 1,035 ppm within 5 feet of a storm-water drain. There is

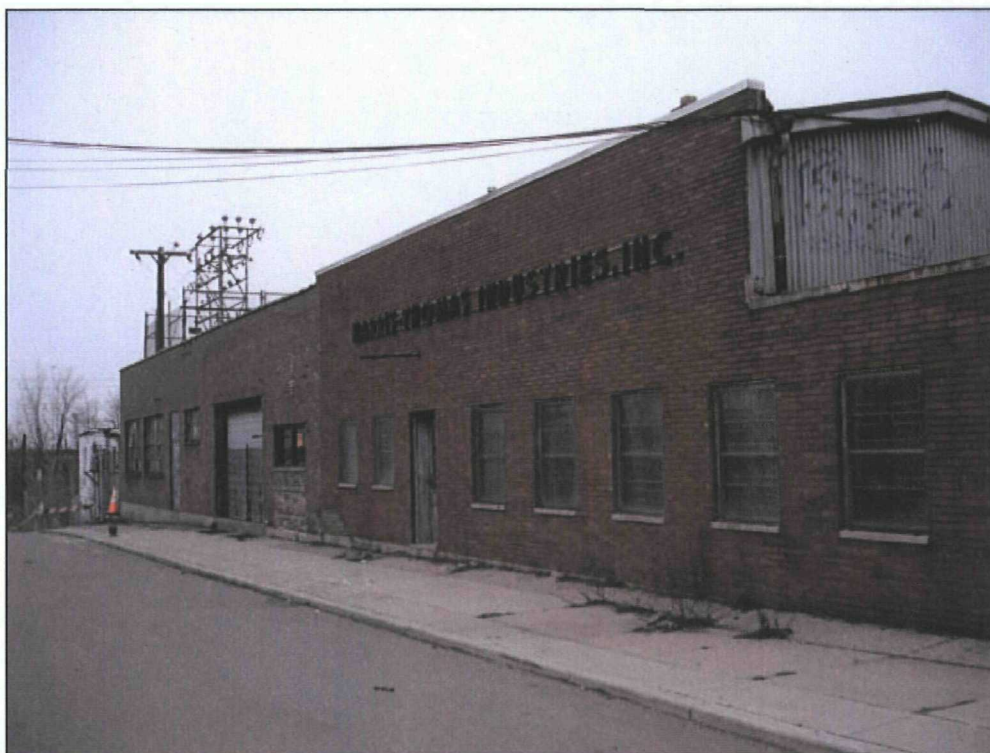
Photo 1: Front of the facility

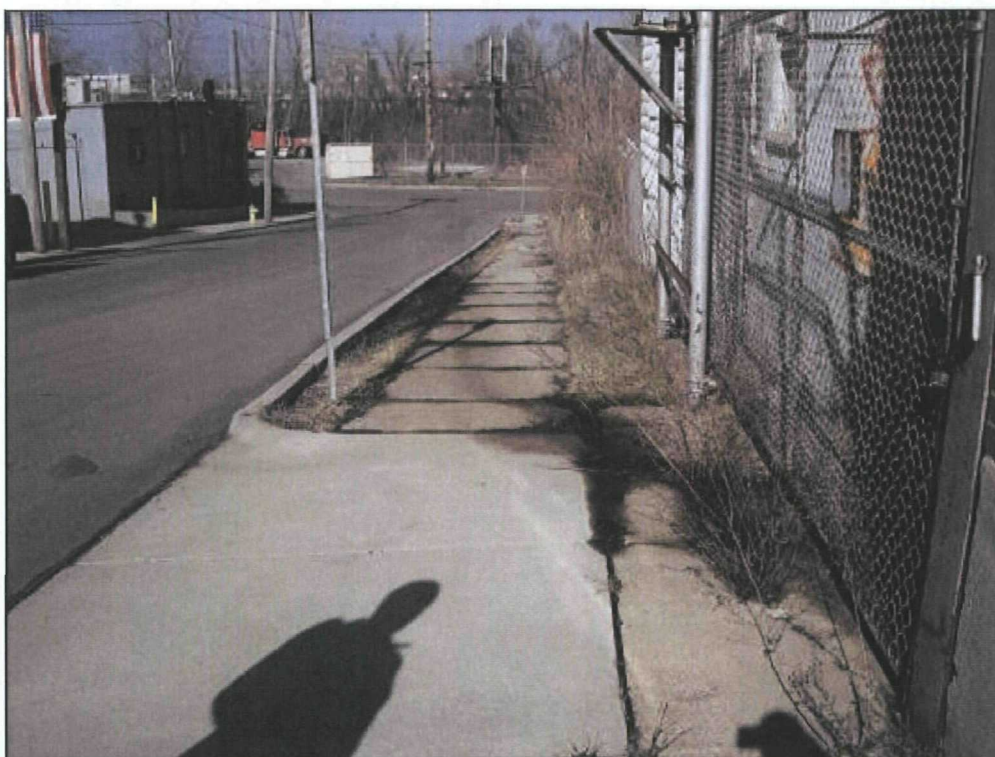
On February 2, 2012, the Dayton Fire Department (DFD) and the Ohio Environmental Protection Agency (Ohio EPA) investigated a report of transformer oil leaking from the facility roof onto a City of Dayton right-of-way sidewalk along Harshman Street. Due to site trespassing and vandalism (from "scrappers"), transformer oil was released and spilled on the roof, building, and adjacent sidewalk. Ohio EPA and DFD conducted a site inspection within the facility and not only observed the oil which

Photo 2: Oil staining on sidewalk from initial release in February 2012

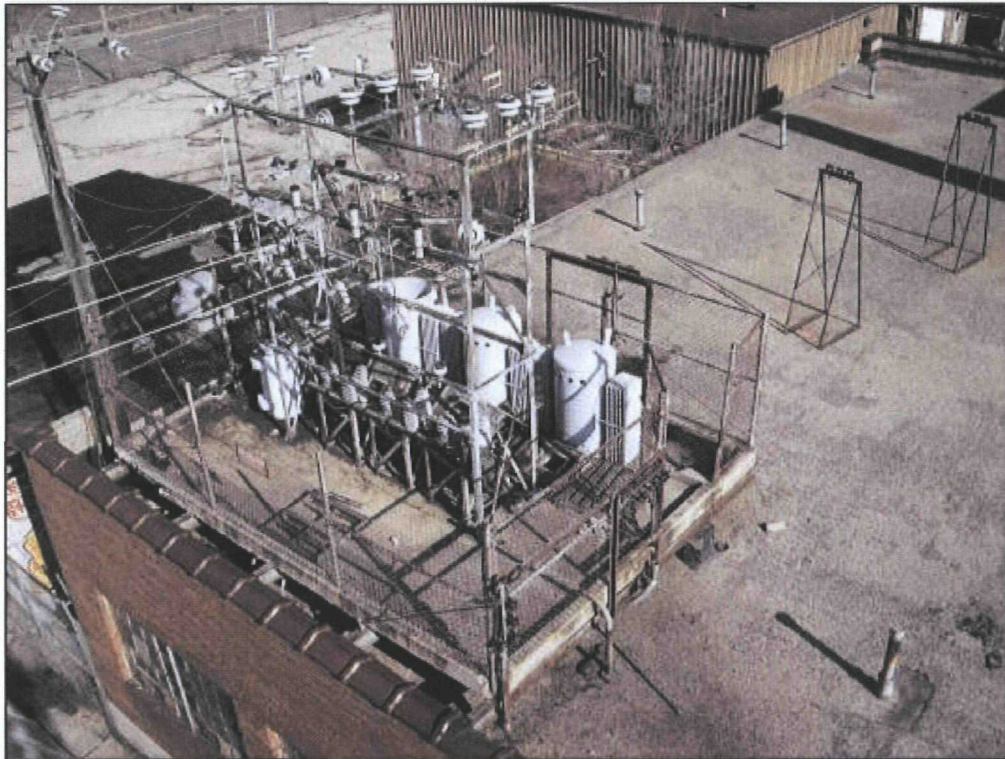
February 3, 2012, was cut and removed and one of the four remaining transformers was tipped over and stolen by "scrappers" to access the copper wiring inside the unit. The oil inside the transformer spilled onto the roof and subsequently off the roof, onto the ground and off-site onto the City of Dayton sidewalk right-of-way. A copy of the police report is included as part of the Administrative Record (Dayton Police Department, March 2012). Ohio EPA requested emergency assistance from U.S. EPA to stabilize the release.

Photo 3: Four transformers on the roof of Building G. Three of these transformers were emptied of its oil by trespassers in February 2012

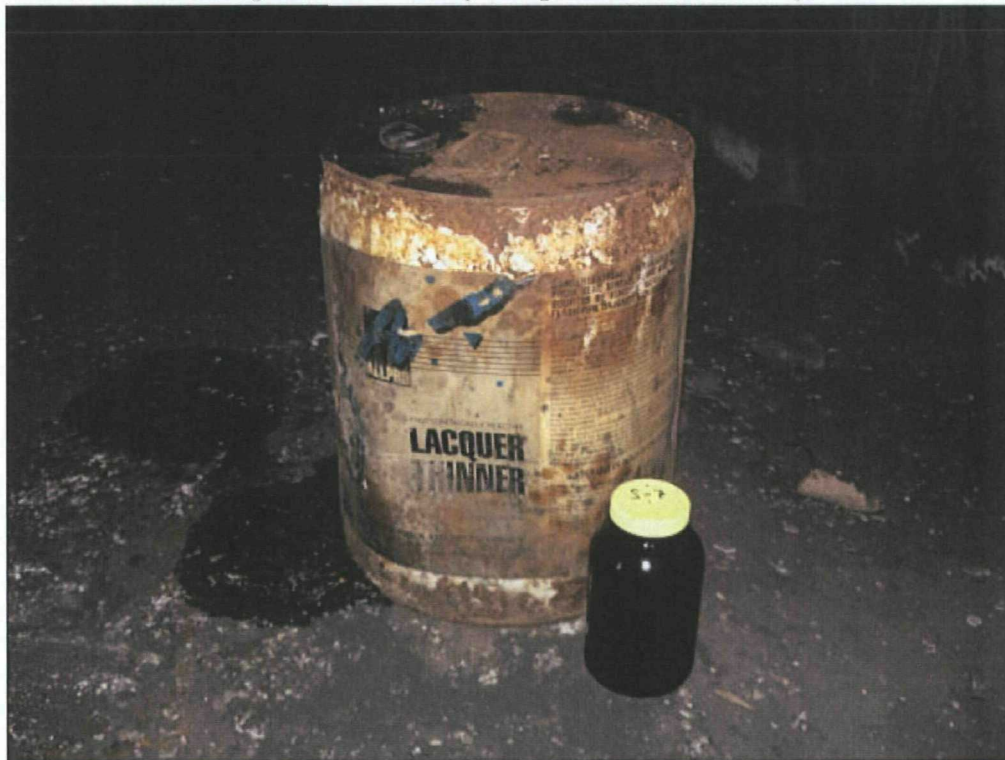
Analytical results from samples S-7, S-11 and S-12 documented liquid having flash points less than 140°F, which, according to 40 C.F.R. § 261.21, verifies the characteristic of a hazardous waste for ignitability (D001).

Analytical results from liquid sample S-7 documented a TCLP MEK concentration of 170,000 milligrams per liter (mg/L). The TCLP MEK concentration is greater than the TCLP MEK regulatory level of 200.0 mg/L, which, according to 40 C.F.R. § 261.24, verifies the characteristic of a hazardous waste for toxicity (D035).

Photo 4: Sample S-7 having a flash point of less than 58°F and a TCLP MEK concentration of 170,000 mg/L

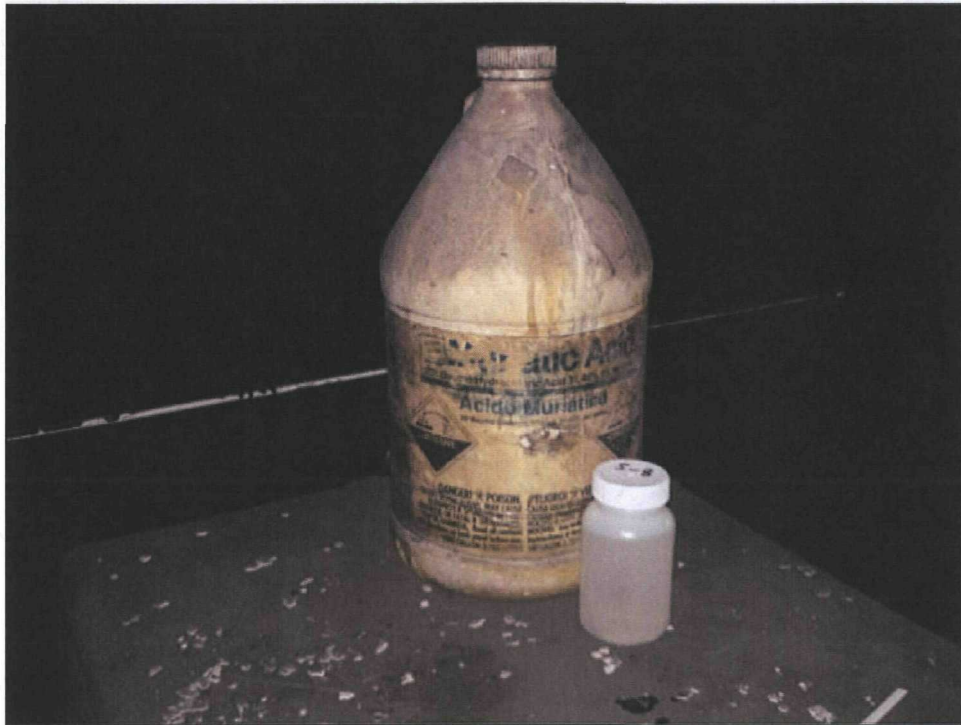
Analytical results from liquid sample S-8 documented liquid waste having a pH level less than 2.0 standard units, which, according to 40 C.F.R. § 261.22, verifies the characteristic of a hazardous waste for corrosivity (D002).

Photo 5: Sample S-8 having a pH of 1.0 standard unit

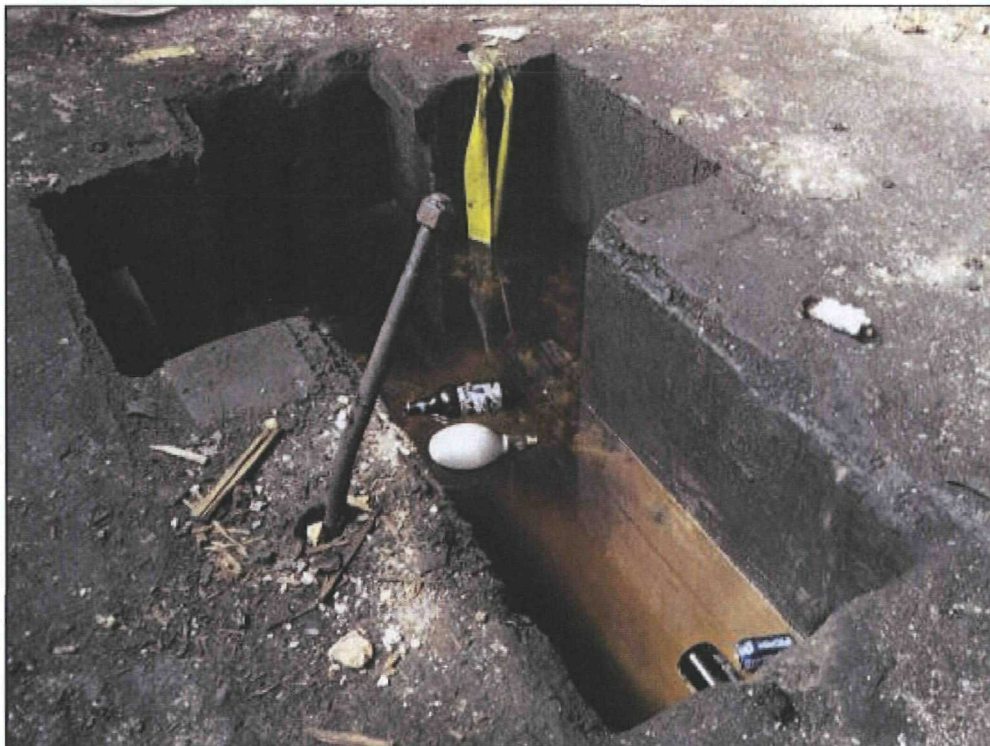
Photo 6: Pit containing unknown liquid

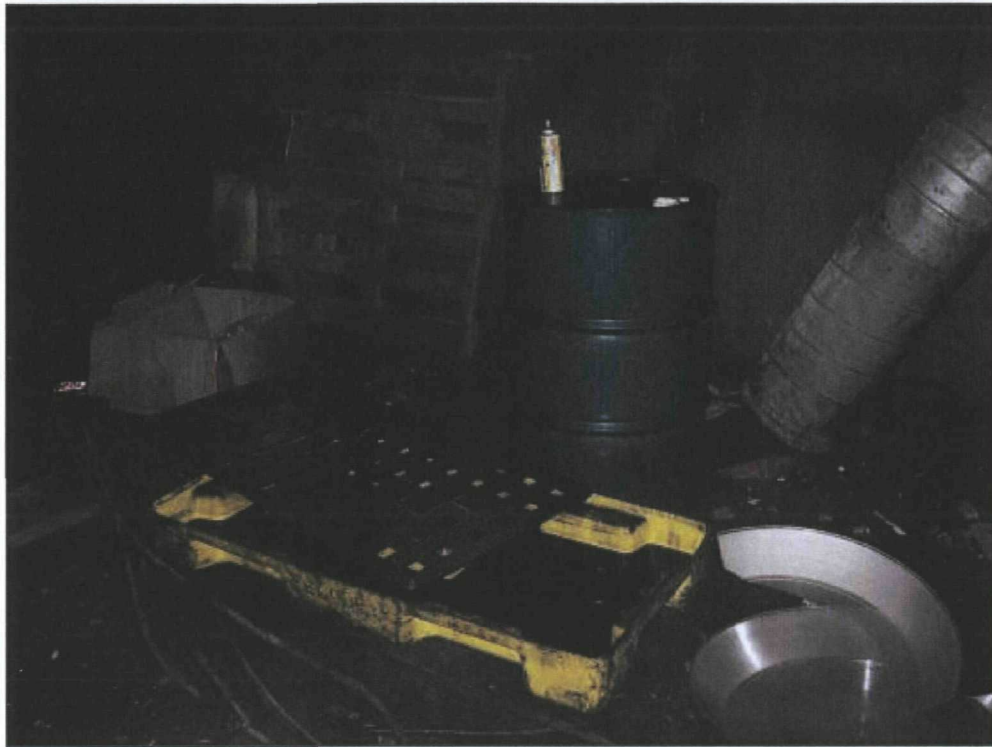
Photo 7: Abandoned 55-gallon drum

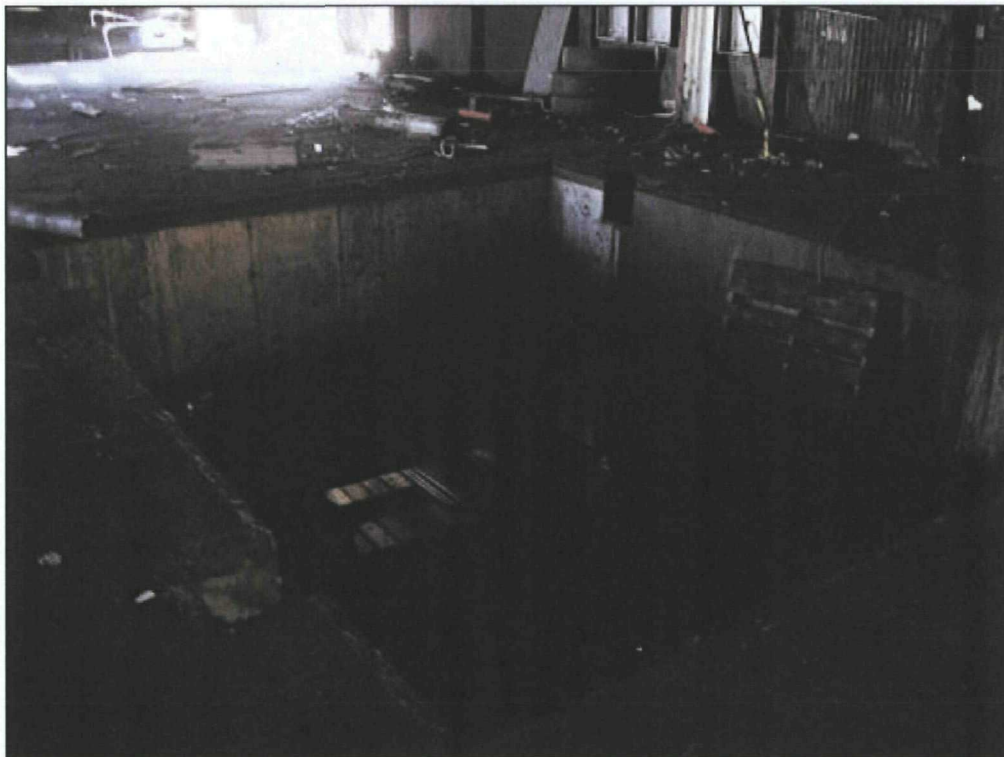
Photo 8: Pit containing unknown liquid

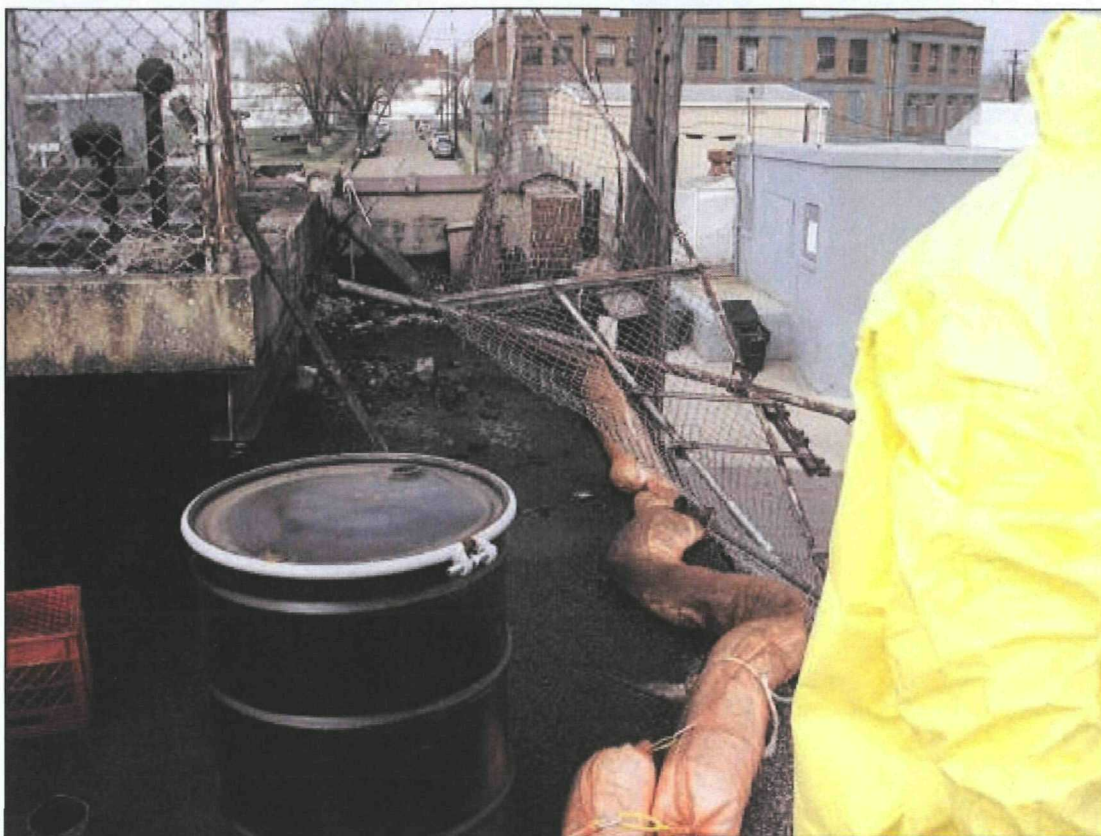
On March 20, 2012, DFD, U.S. EPA, START and ERRS remobilized to the Site and observed that the fencing surrounding the transformers had been breached and that one of the transformers had been stolen and the oil within the transformer had been released onto the roof. ERRS spread absorbent onto the areas where oil was pooled or stained on the roof and the ground. In addition, ERRS replaced the absorbent boom which had been impacted by the release and added additional layers of the absorbent boom at the point where the release had exited the Site.

**Photo 9: Fencing surrounding transformers that was cut down by trespassers.
Notice the oil staining on the roof**
